| REPORT TITLE<br><b>Civil Engineering Site Review</b><br><br>PROJECT DESCRIPTION<br>Culvert, drainage and concrete details | PROJECT NO.<br>ENG-26067 | CLIENT<br>Example Properties | SITE<br>Brookside Culvert |

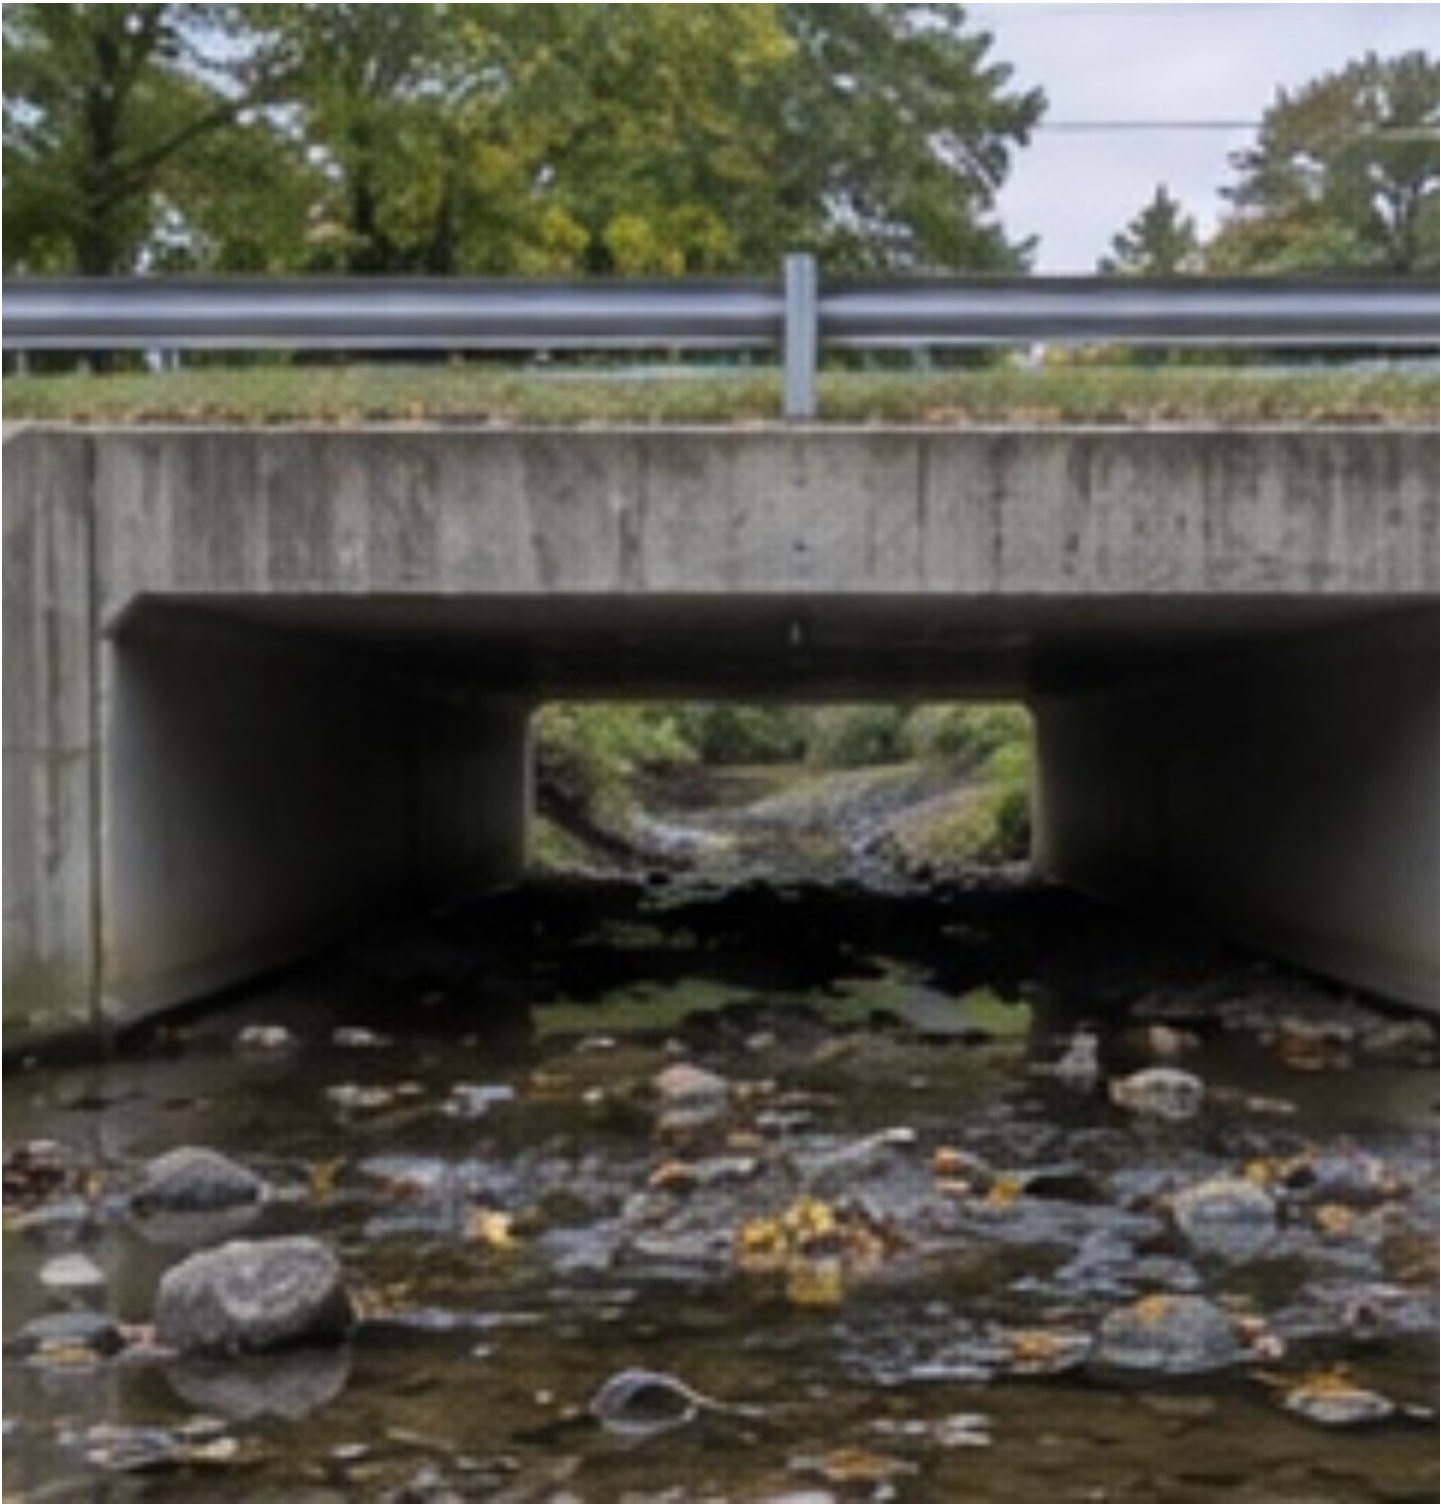
Photo 1: Culvert inlet and road embankment.

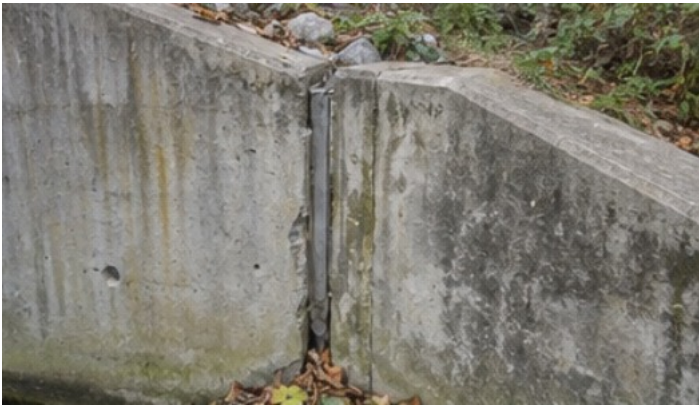
Photo 2: Concrete wingwall joint condition.

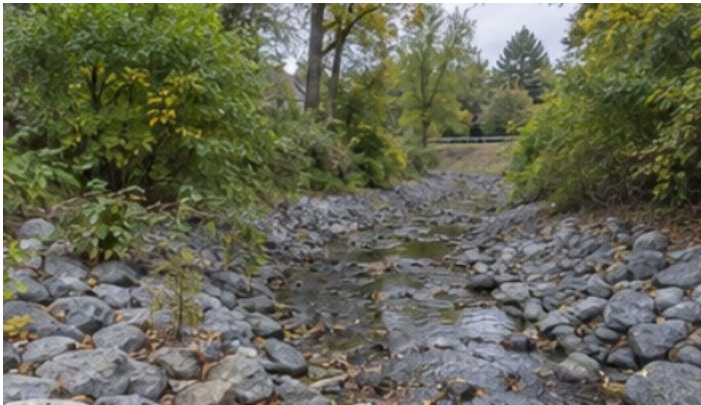
Photo 3: Downstream channel and erosion protection.

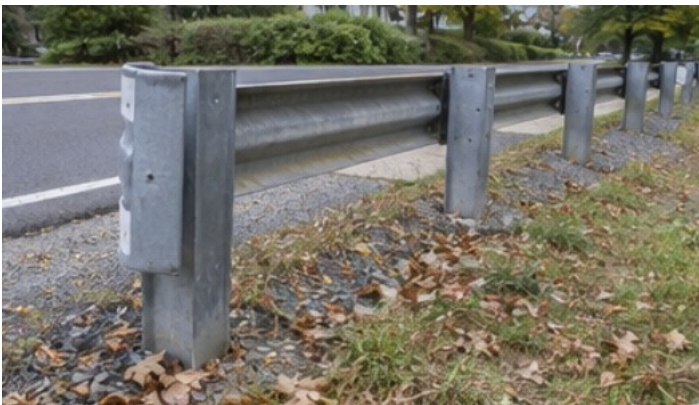
Photo 4: Roadside guardrail and support posts.

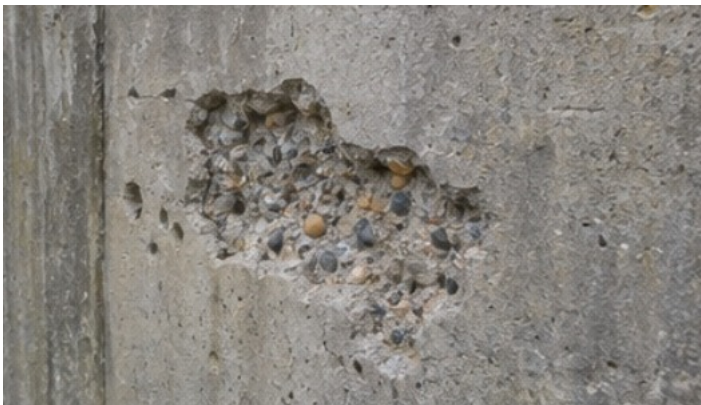
Photo 5: Localized concrete surface deterioration.

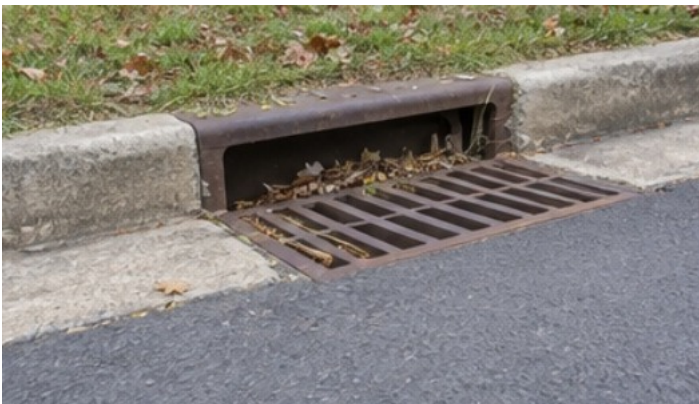
Photo 6: Catch basin at the curb.

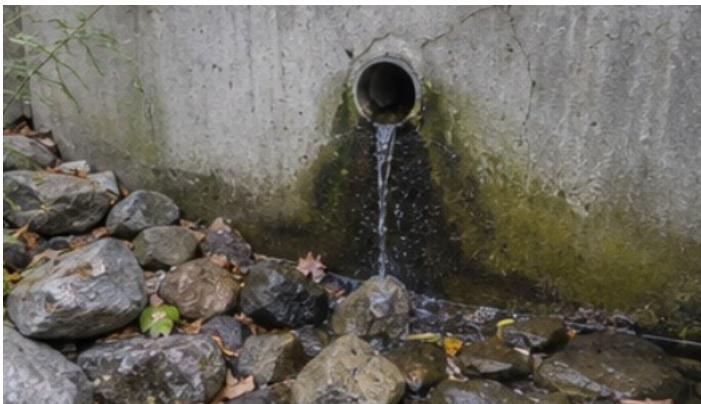
Photo 7: Retaining wall drainage outlet.

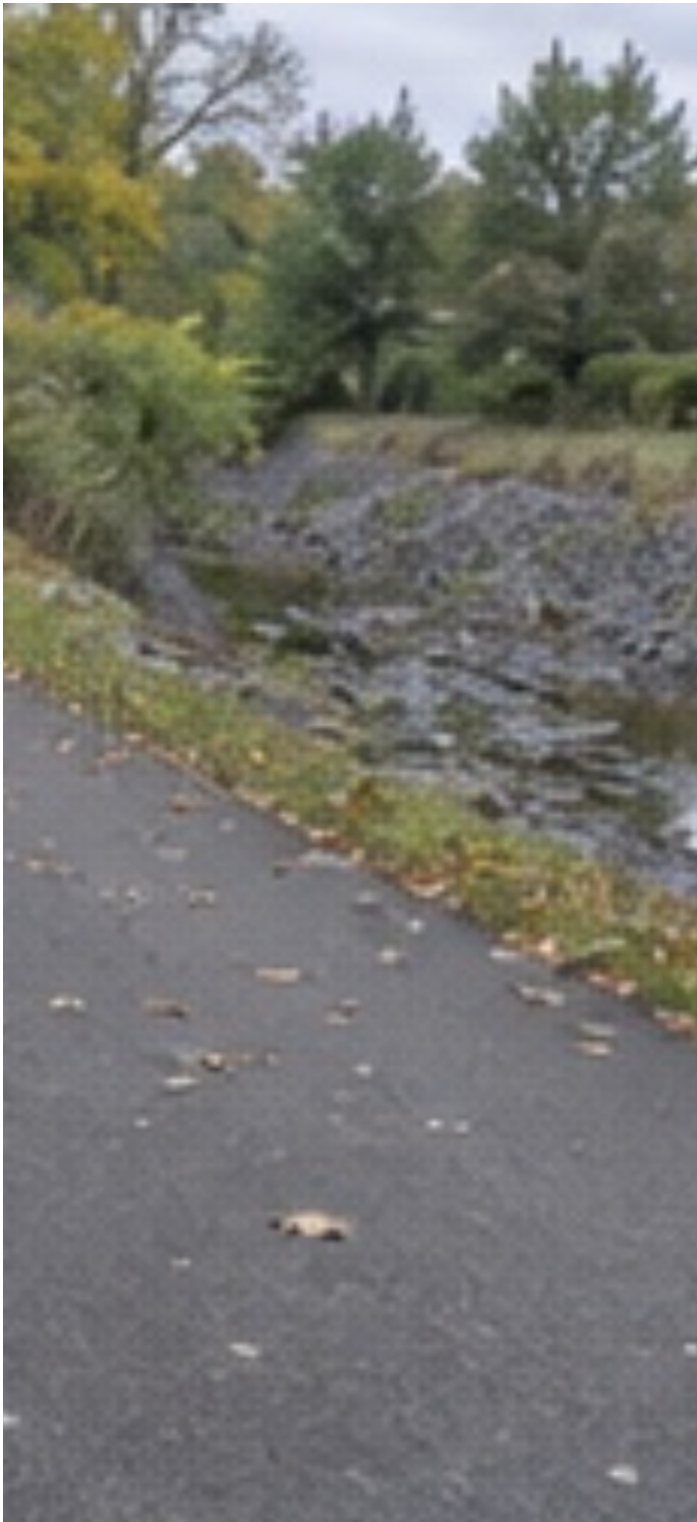
Photo 8: Pedestrian path beside the channel.

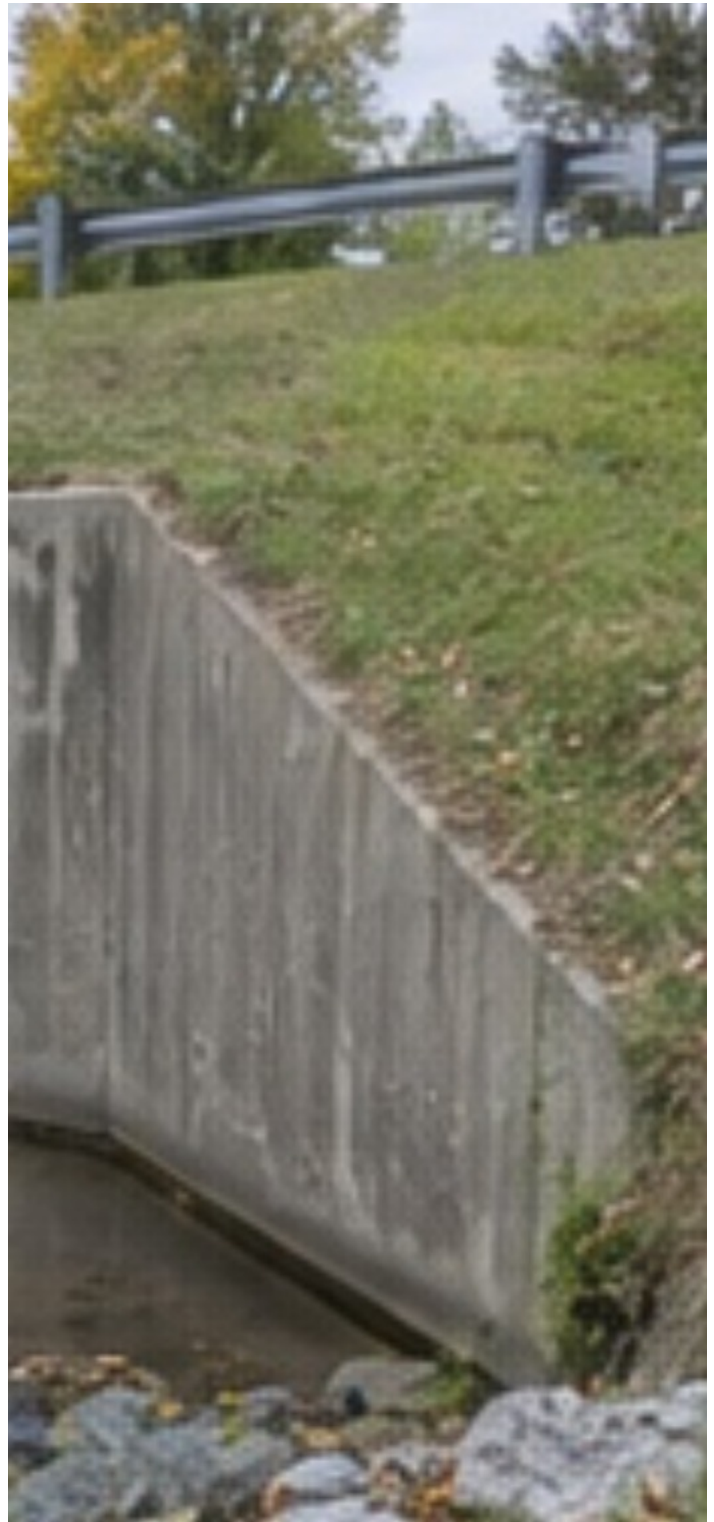
Photo 9: Headwall and adjacent grass slope.

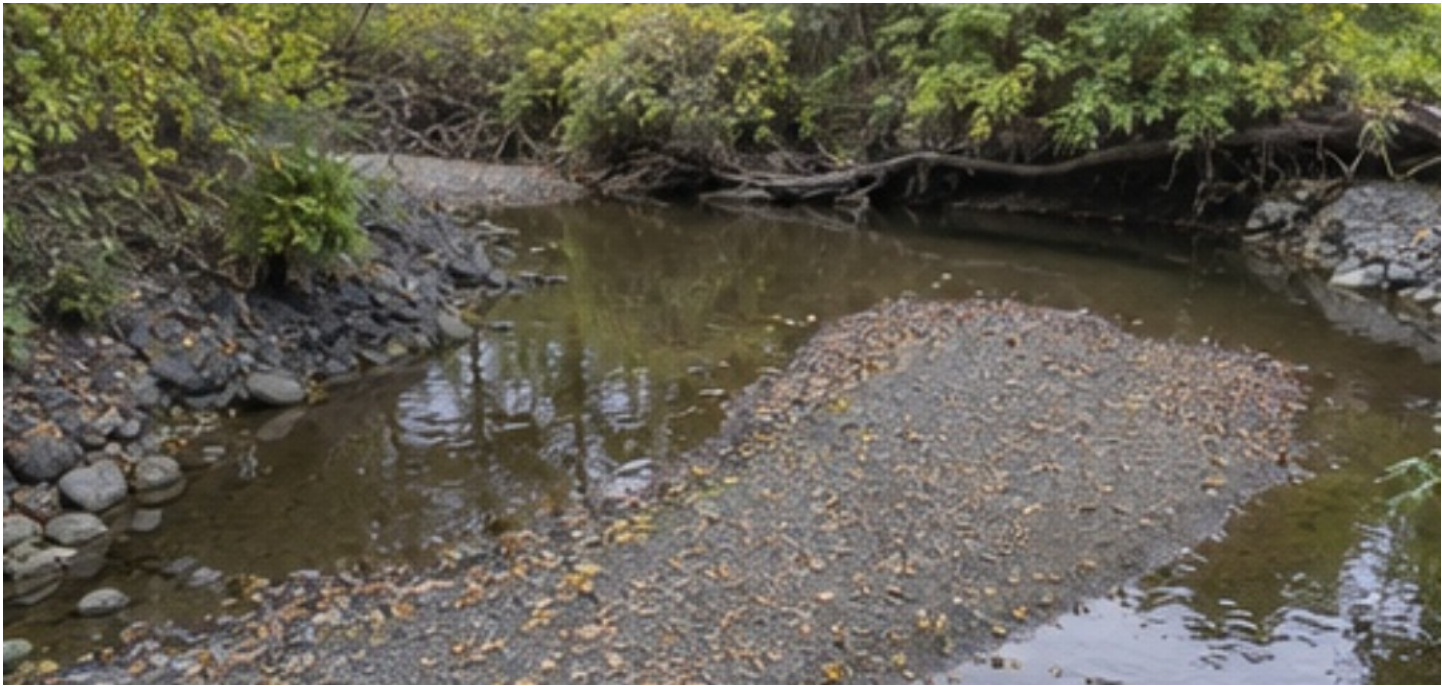
Photo 10: Sediment at the channel bend.

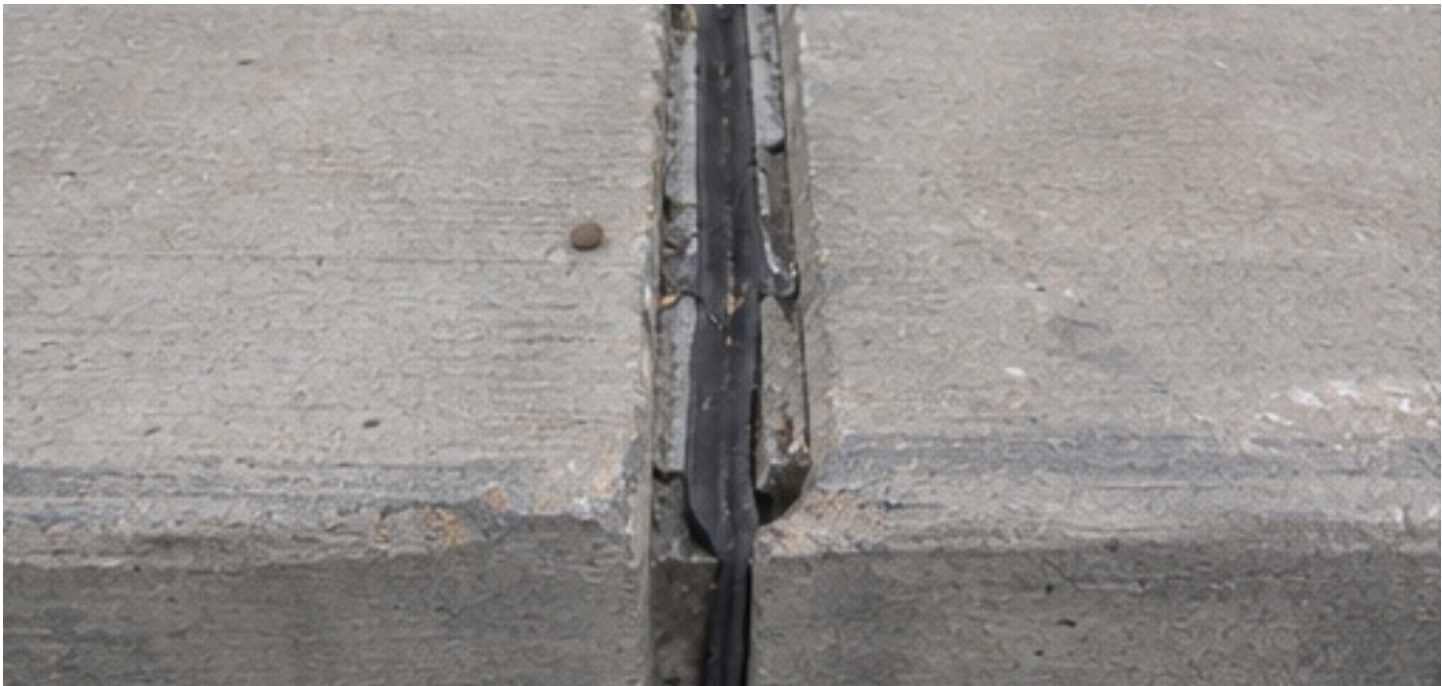
Photo 11: Expansion joint sealant condition.
