| <div>REPORT TITLE</div> <div>Phase I ESA Site Review</div> <div>PROJECT DESCRIPTION</div> <div>Site reconnaissance and storage areas</div> | <div>PROJECT NO.</div> <div>ESA-26041</div> | <div>CLIENT</div> <div>Example Properties</div> | <div>SITE</div> <div>Riverview Works</div> |

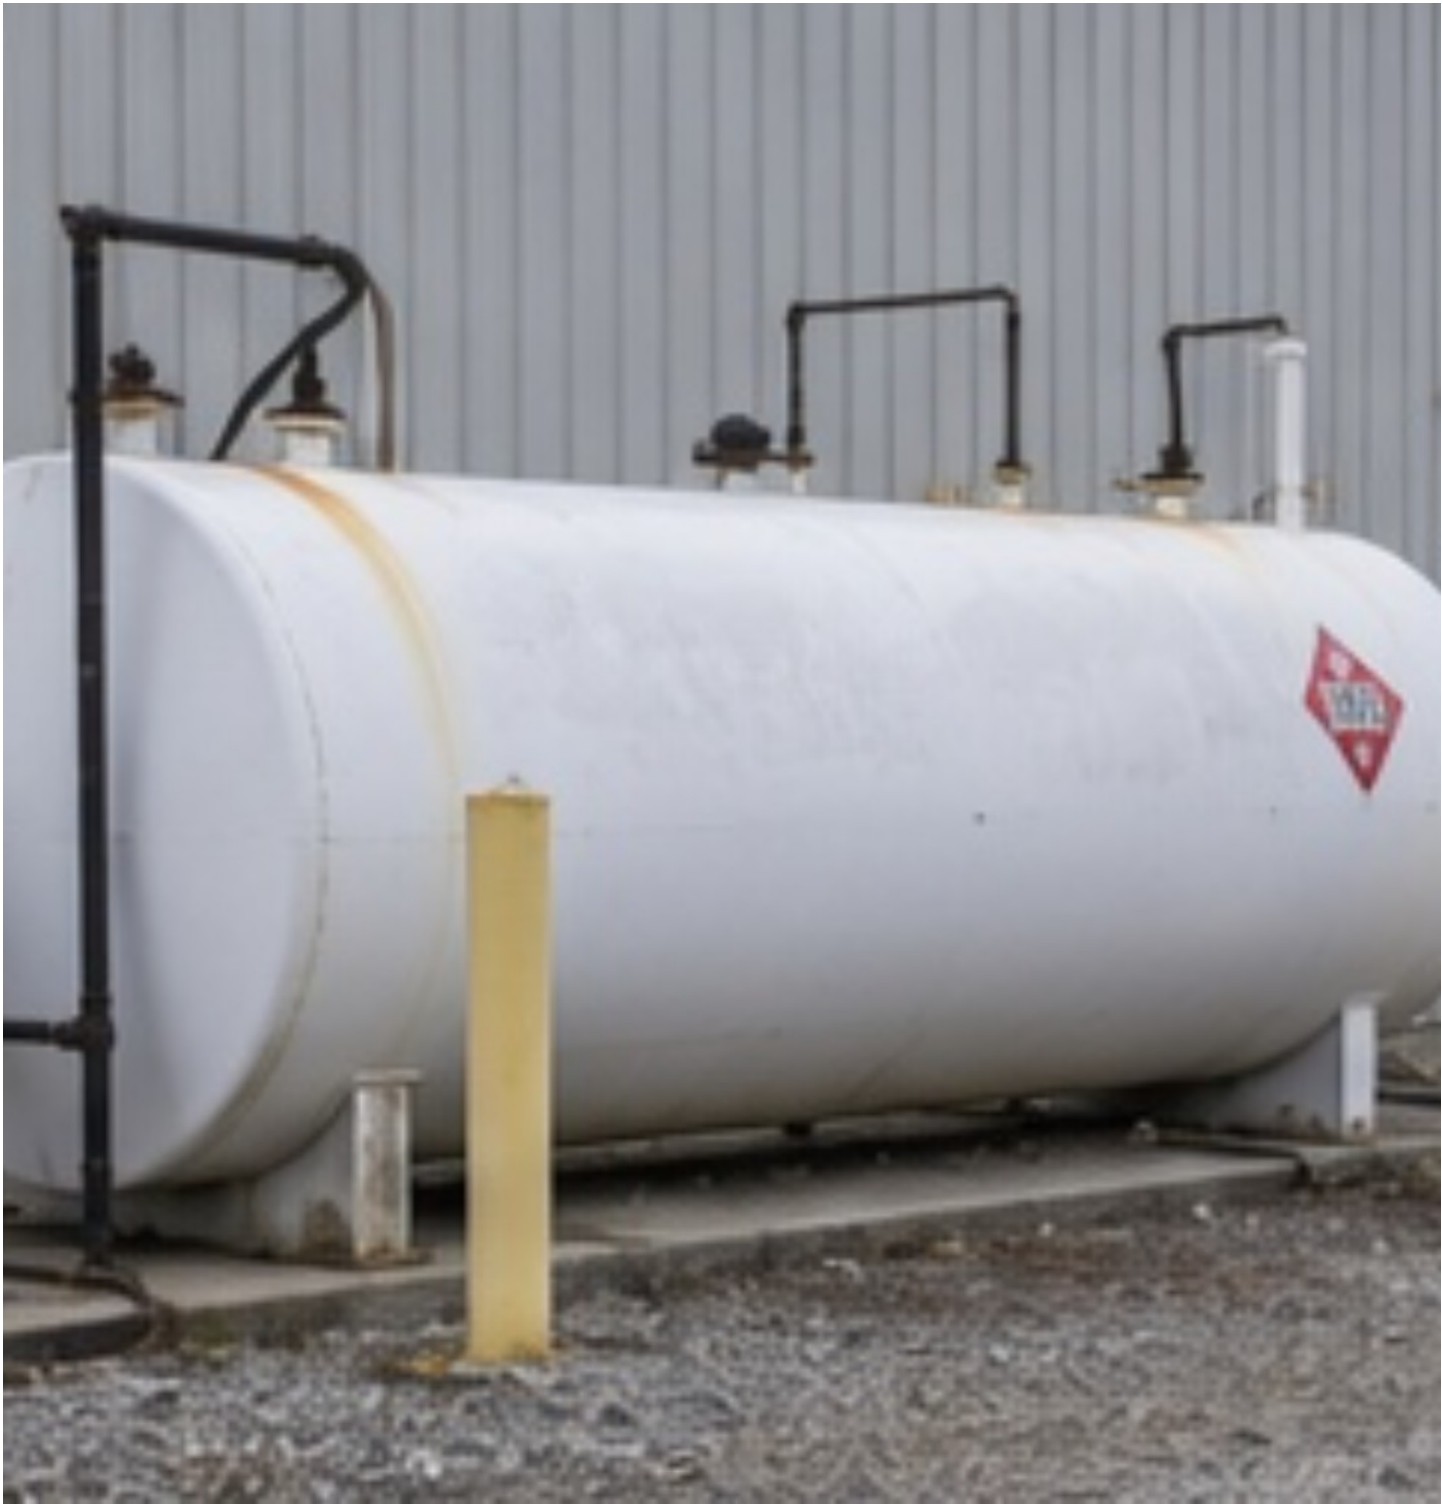
Photo 1: Aboveground fuel tank beside the maintenance building.

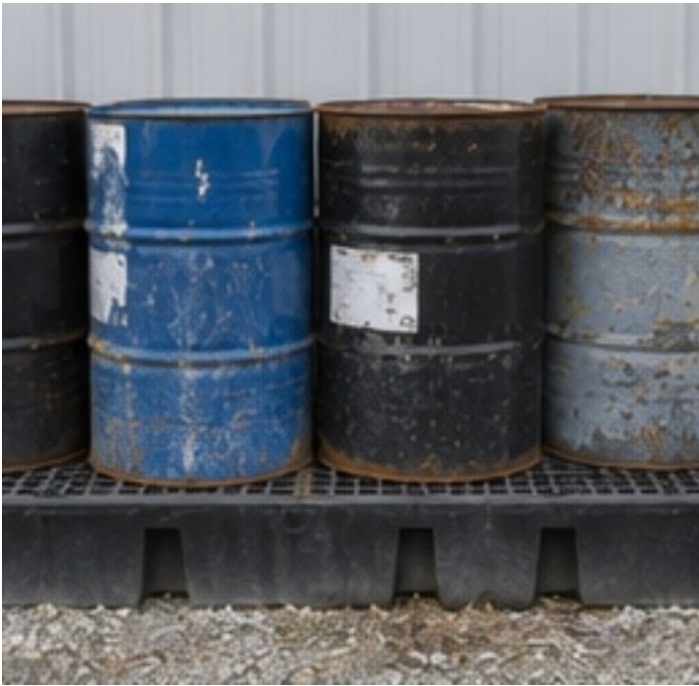
Photo 2: Drum storage on a containment pallet.

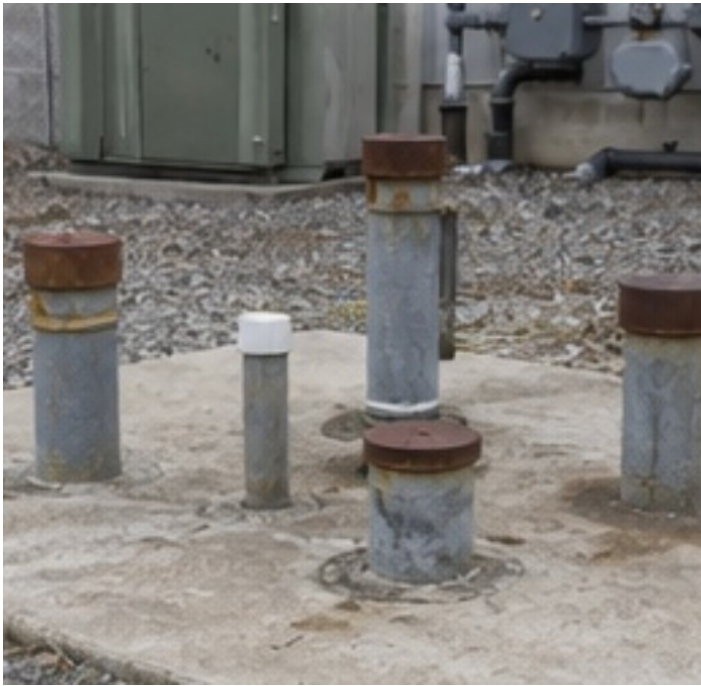
Photo 3: Capped service connections at the former equipment pad.

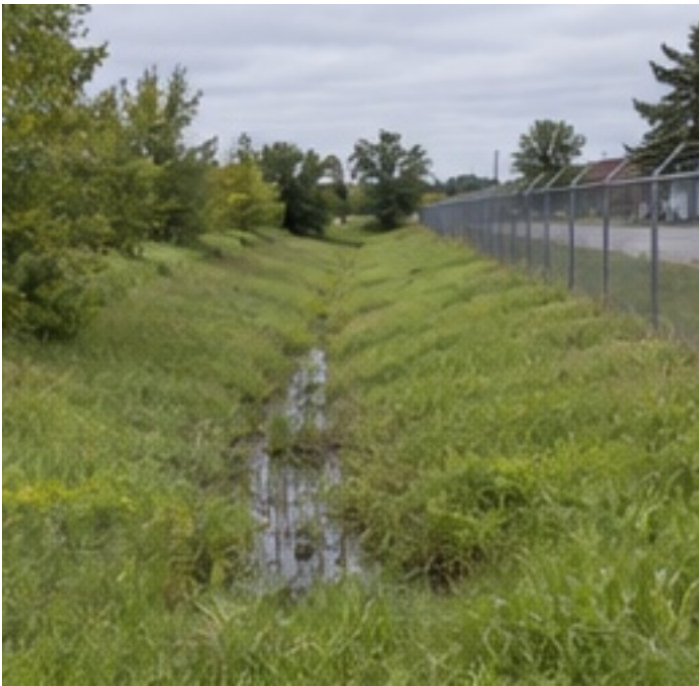
Photo 4: Surface drainage along the property boundary.

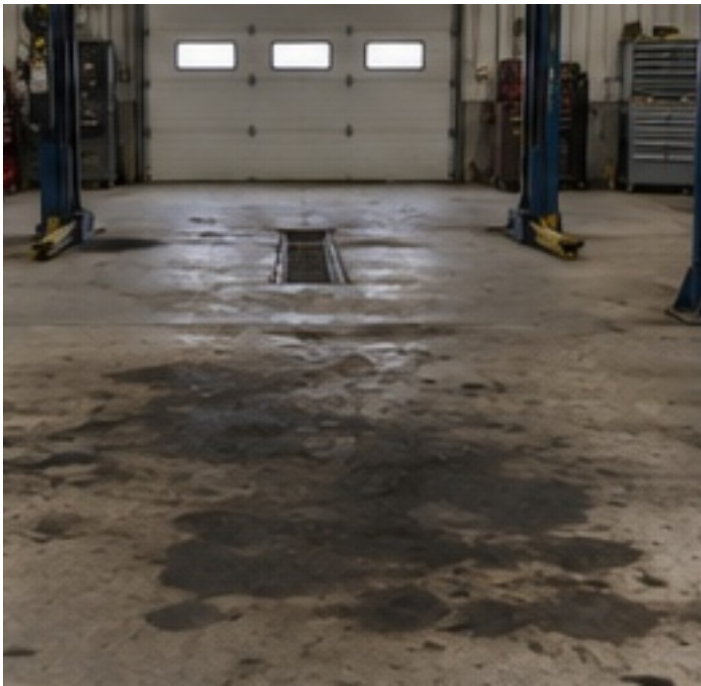
Photo 5: Concrete condition in the vehicle maintenance bay.

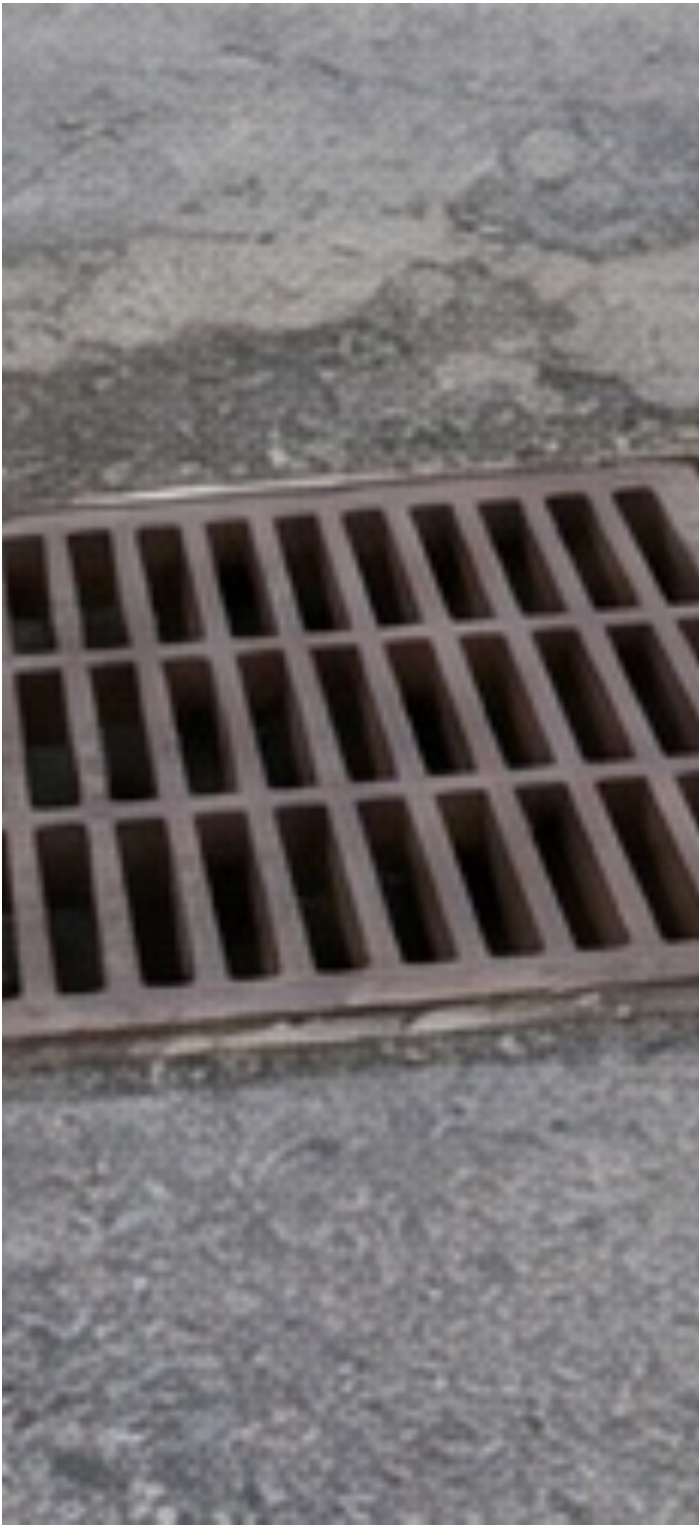
Photo 6: Catch basin in the paved service yard.

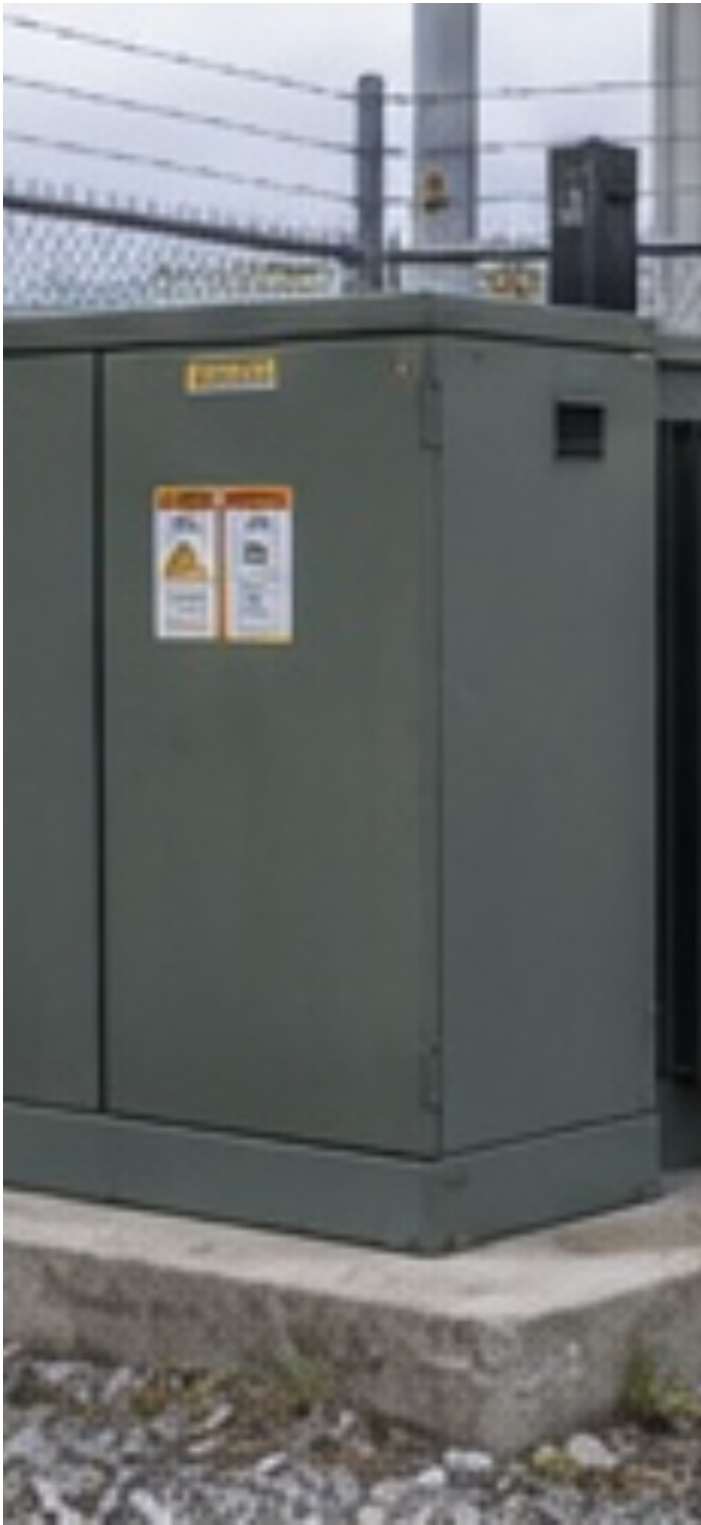
Photo 7: Electrical transformer enclosure.

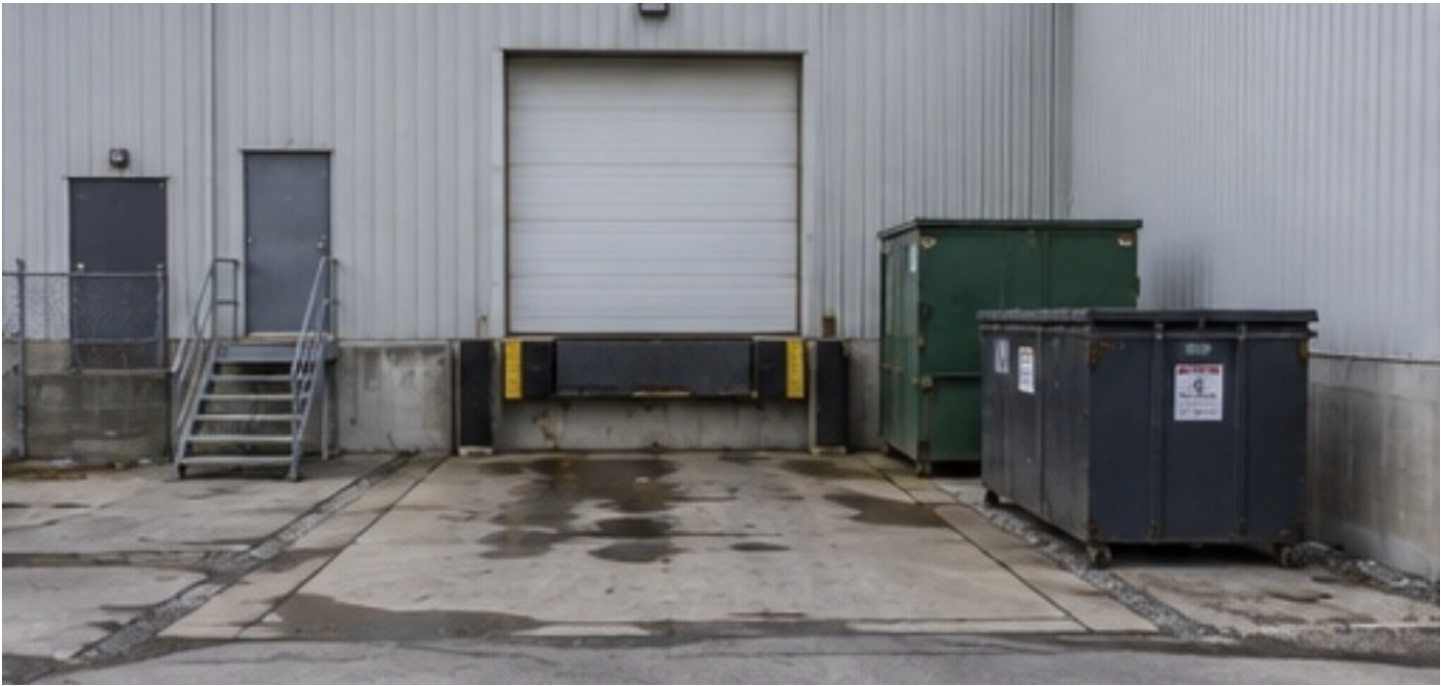
Photo 8: Loading dock and waste storage area.

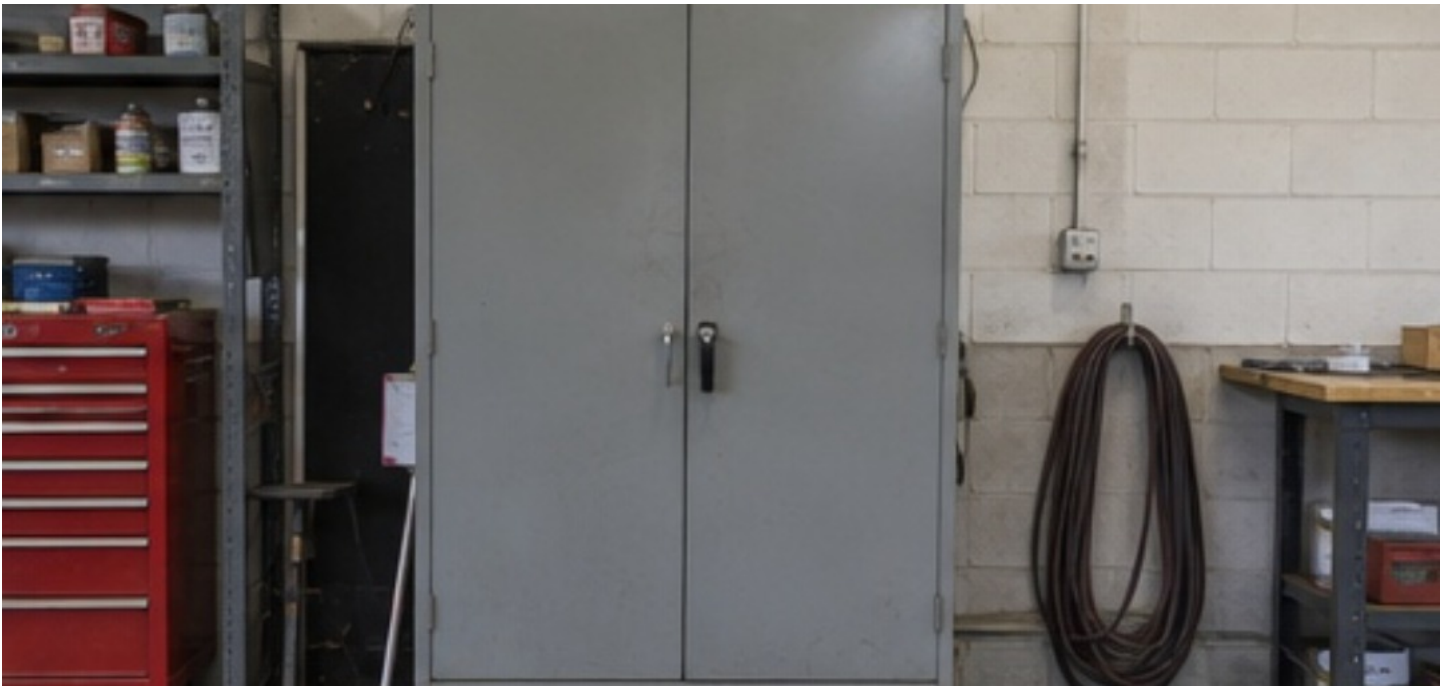
Photo 9: Workshop storage cabinet.
