| <div>REPORT TITLE</div> <div>Property Condition Survey</div> <div>PROJECT DESCRIPTION</div> <div>Exterior and interior condition record</div> | <div>PROJECT NO.</div> <div>PCI-26032</div> | <div>CLIENT</div> <div>Example Properties</div> | <div>SITE</div> <div>Maple Court House</div> |
| | <div>DATE</div> <div>2026-09-09</div> | <div>PREPARED</div> <div>A. Morgan</div> | |
| | <div>COMPANY</div> <div>Fieldstone Consulting</div> | <div>SHEET</div> <div>1 of 4</div> | |

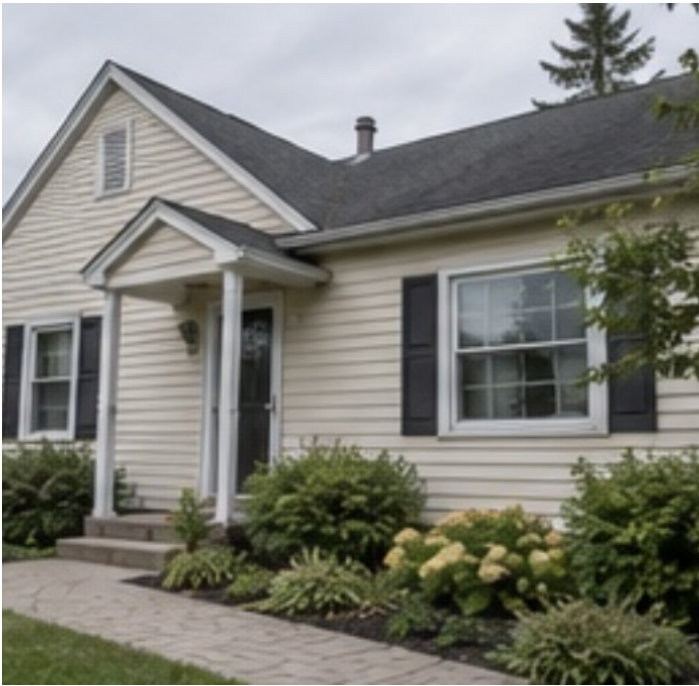
Photo 1: Front elevation and pedestrian approach.

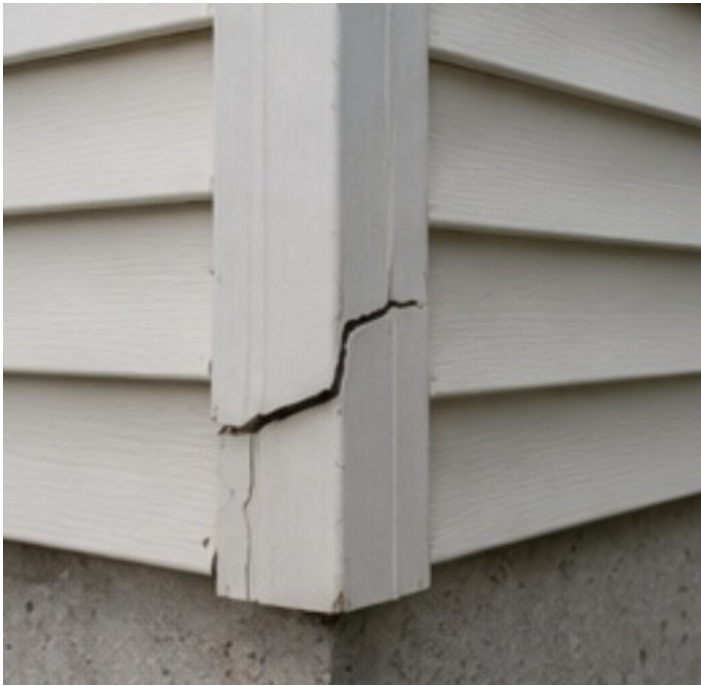
Photo 2: Damaged siding at the building corner.

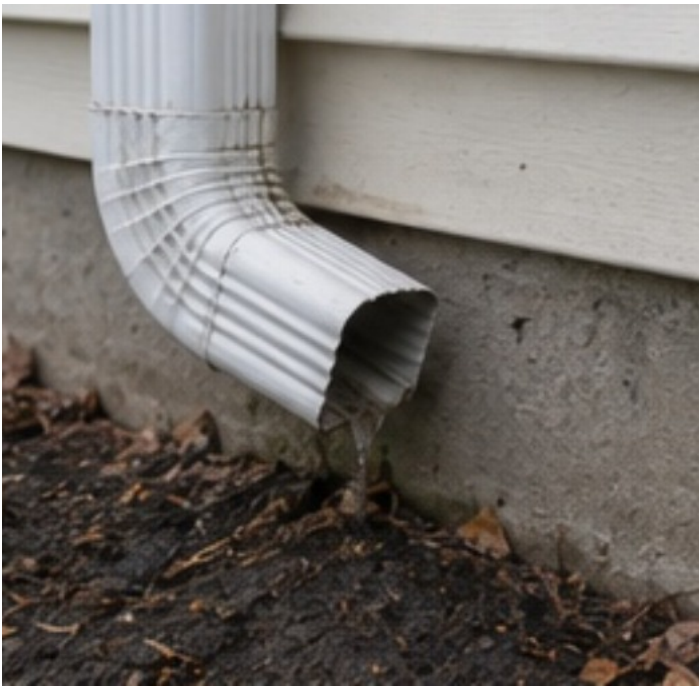
Photo 3: Downspout discharge beside the foundation.

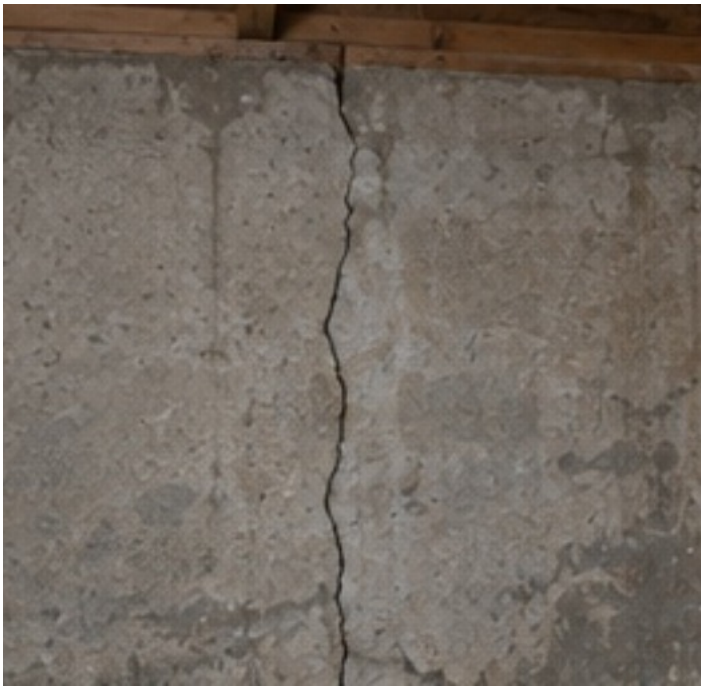
Photo 4: Vertical crack in the basement wall.

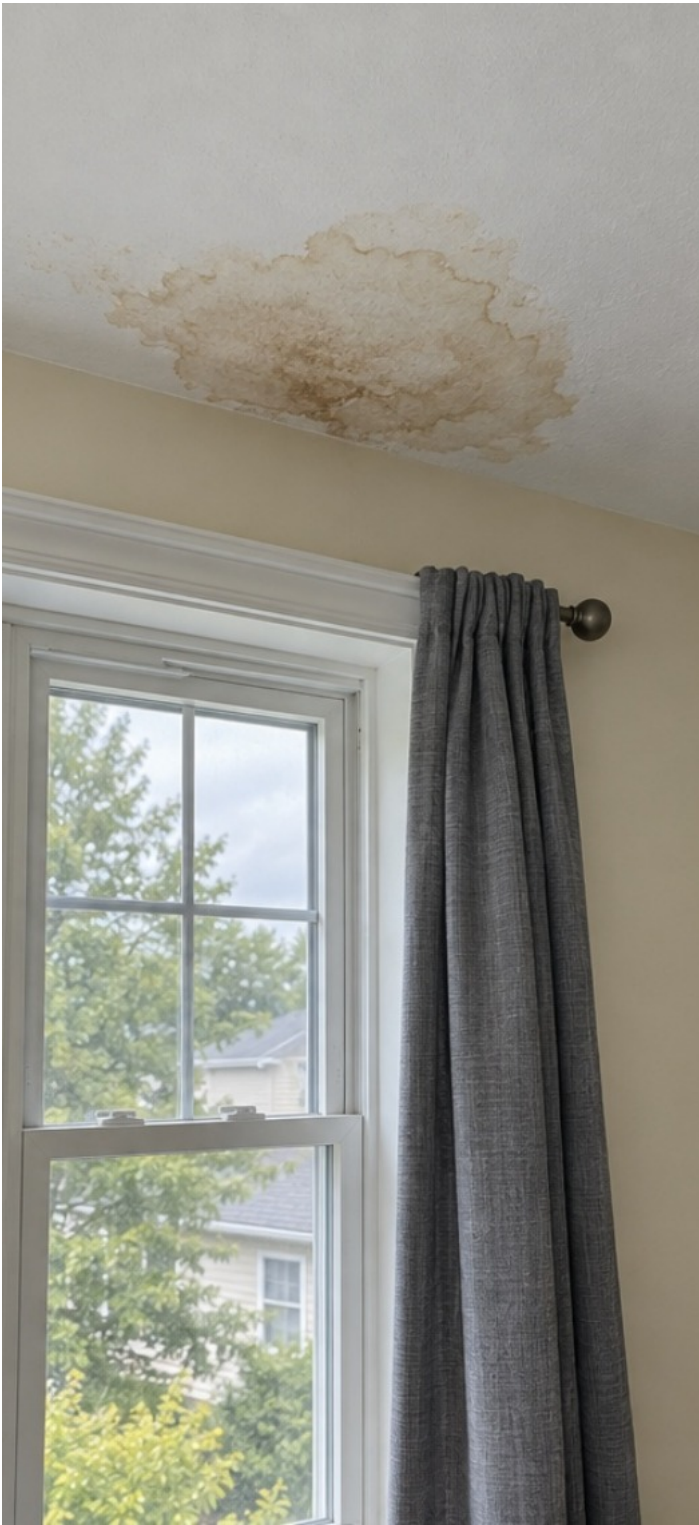
Photo 5: Ceiling staining above the bedroom window.

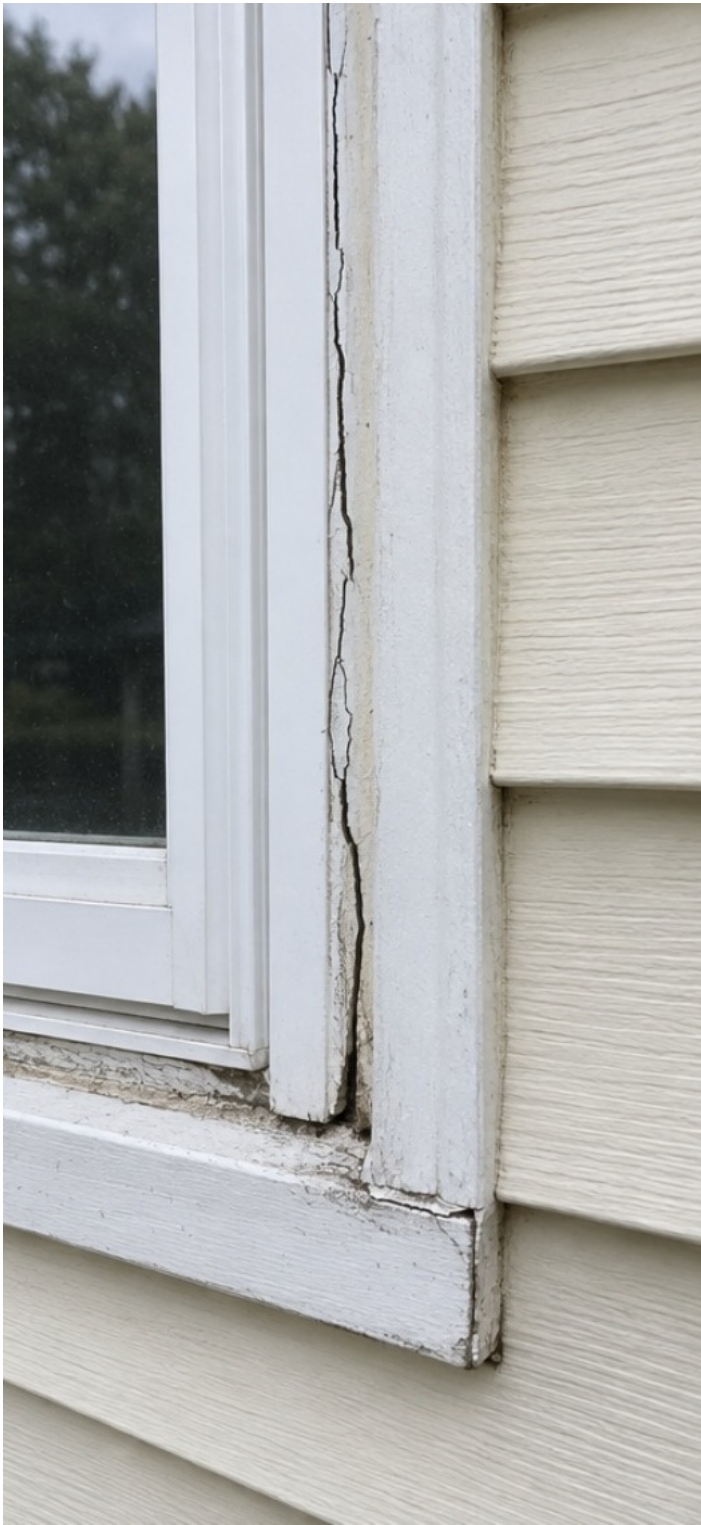
Photo 6: Window perimeter sealant condition.

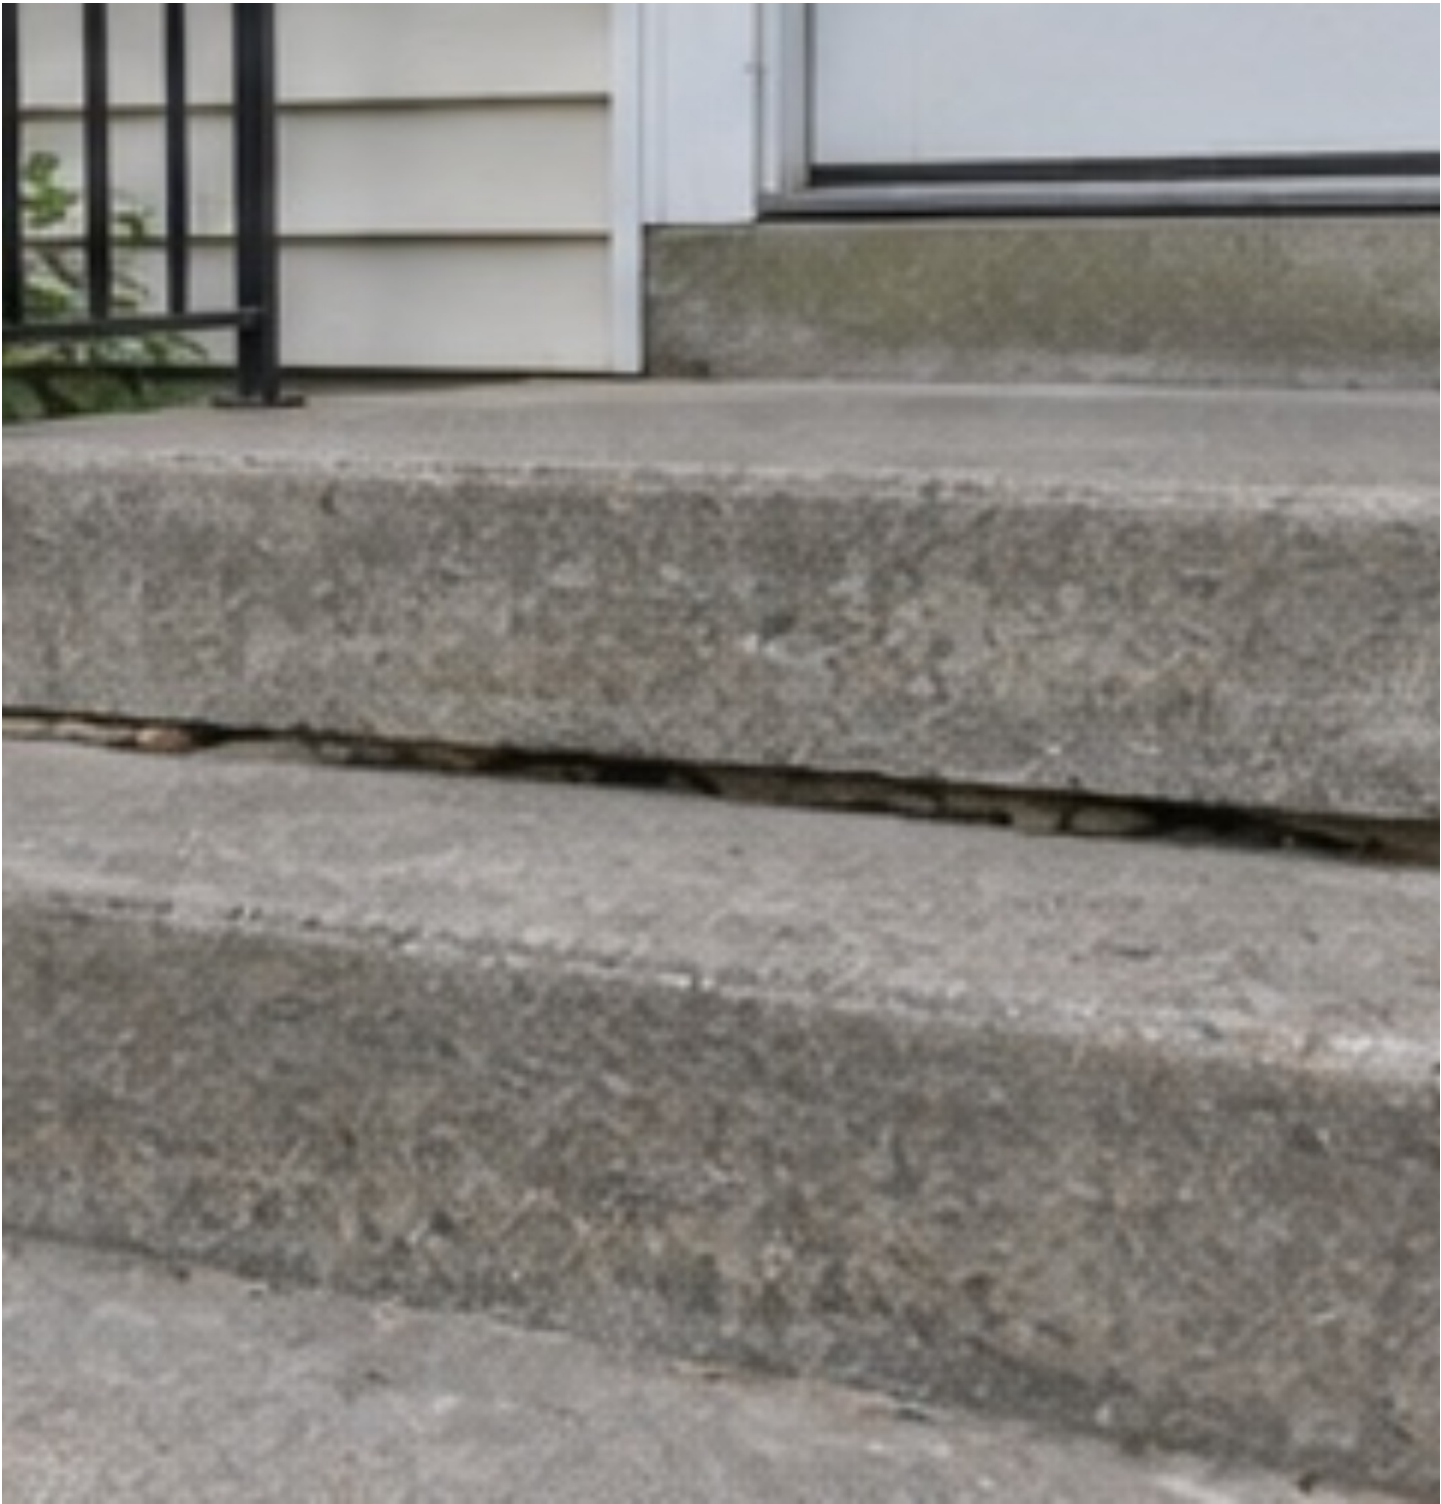
Photo 7: Concrete entry step condition.

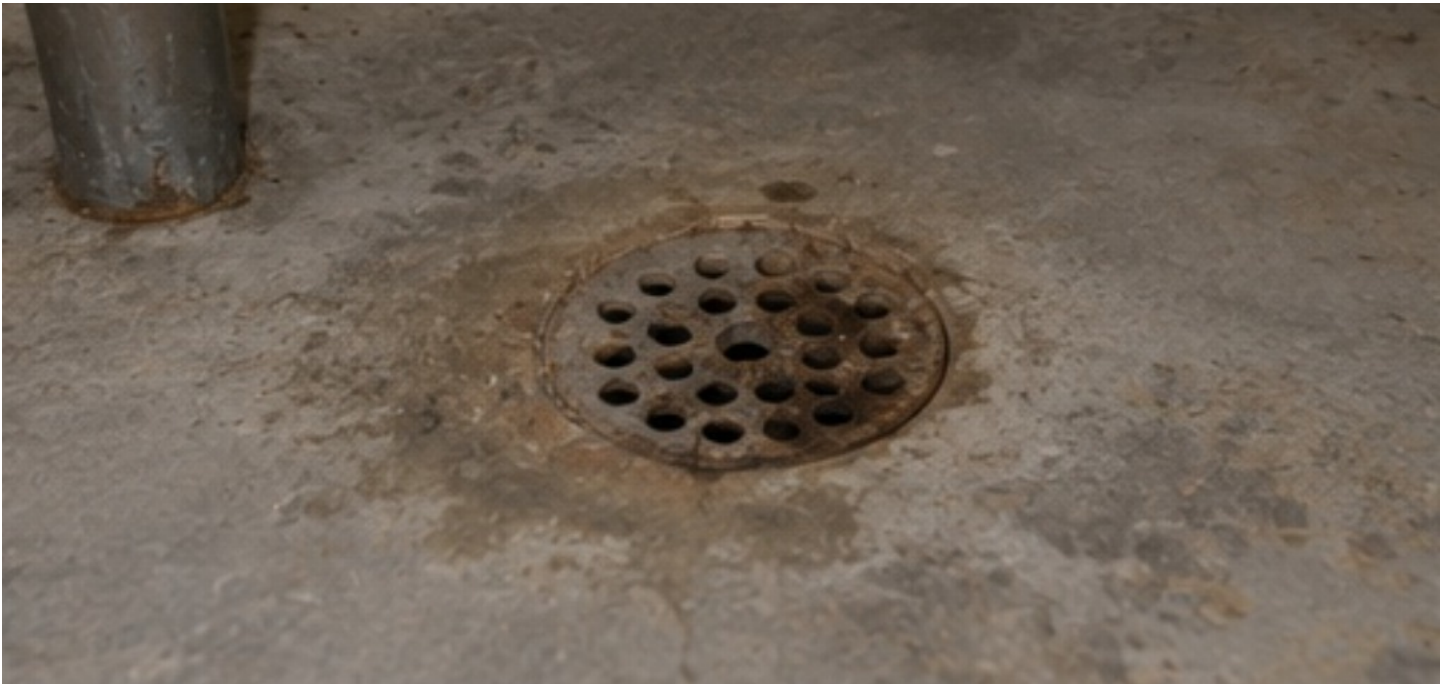
Photo 8: Basement floor drain.

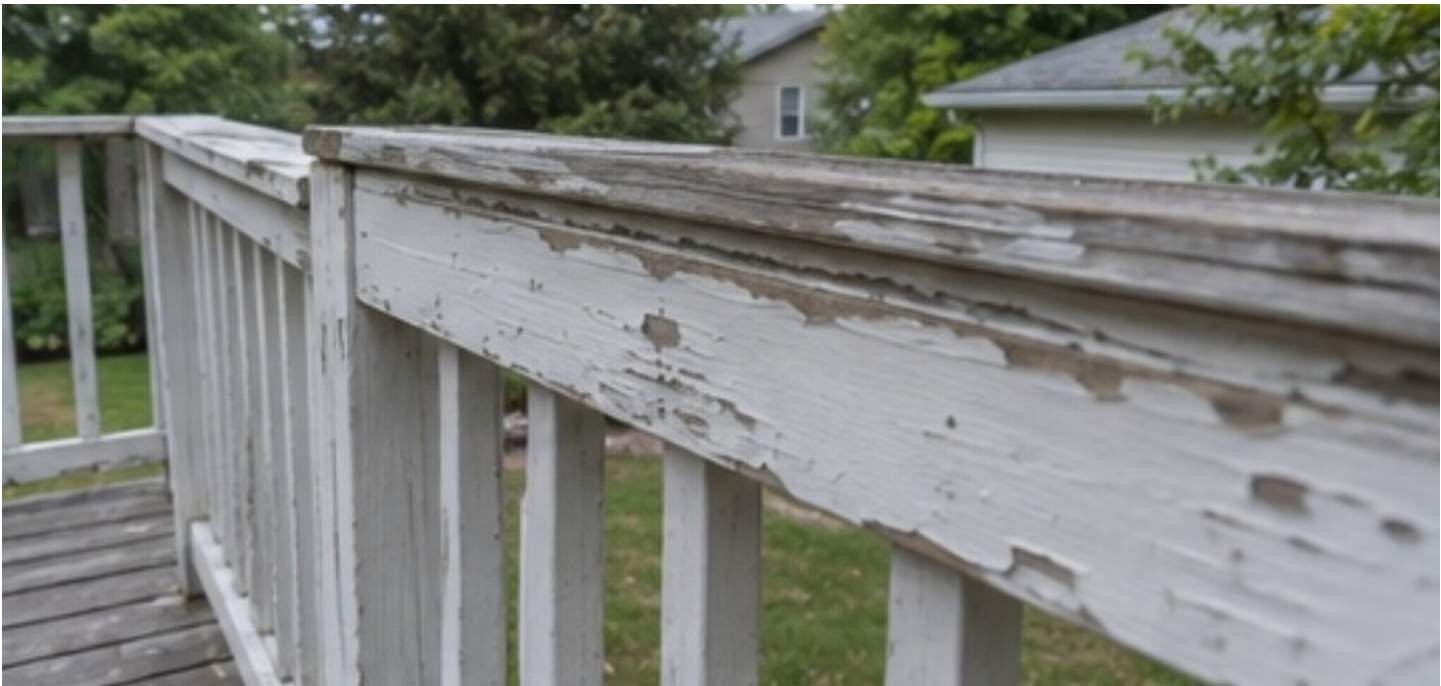
Photo 9: Weathering on the deck railing.
