| <div>REPORT TITLE</div> <div>Roof Condition Survey</div> <div>PROJECT DESCRIPTION</div> <div>Roof covering and drainage details</div> | <div>PROJECT NO.</div> <div>ROOF-26019</div> | <div>CLIENT</div> <div>Example Properties</div> | <div>SITE</div> <div>Cedar Lane House</div> |

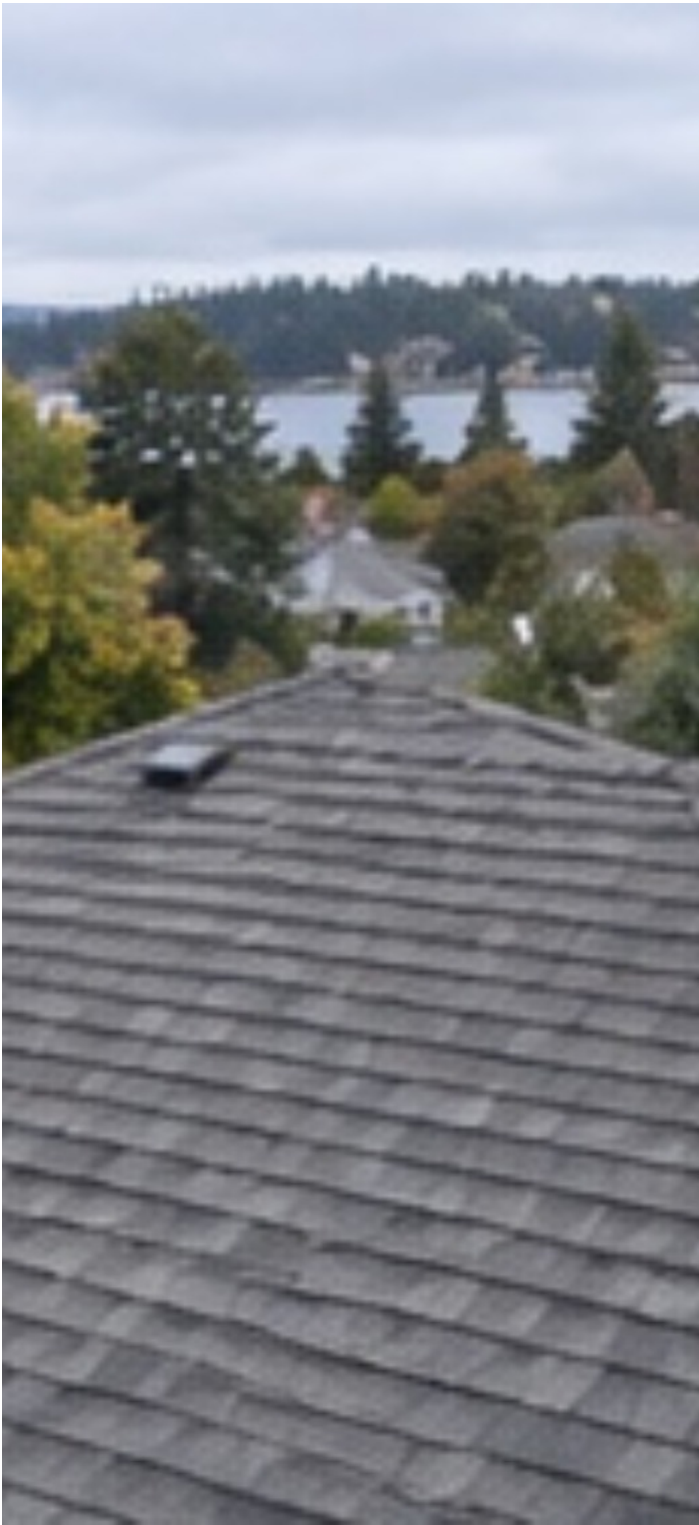
Photo 1: Overview of the roof and chimney.

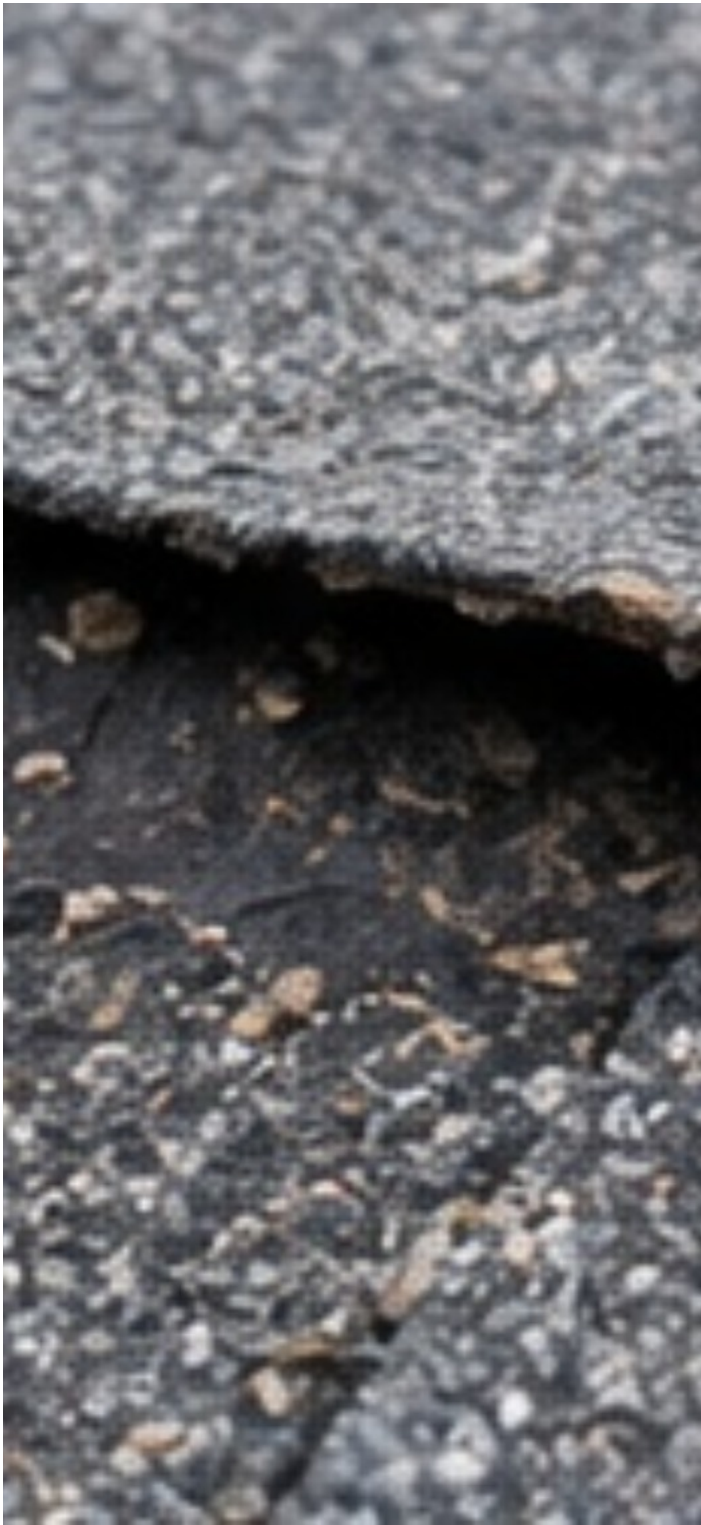
Photo 2: Lifted shingle edge and granule loss.

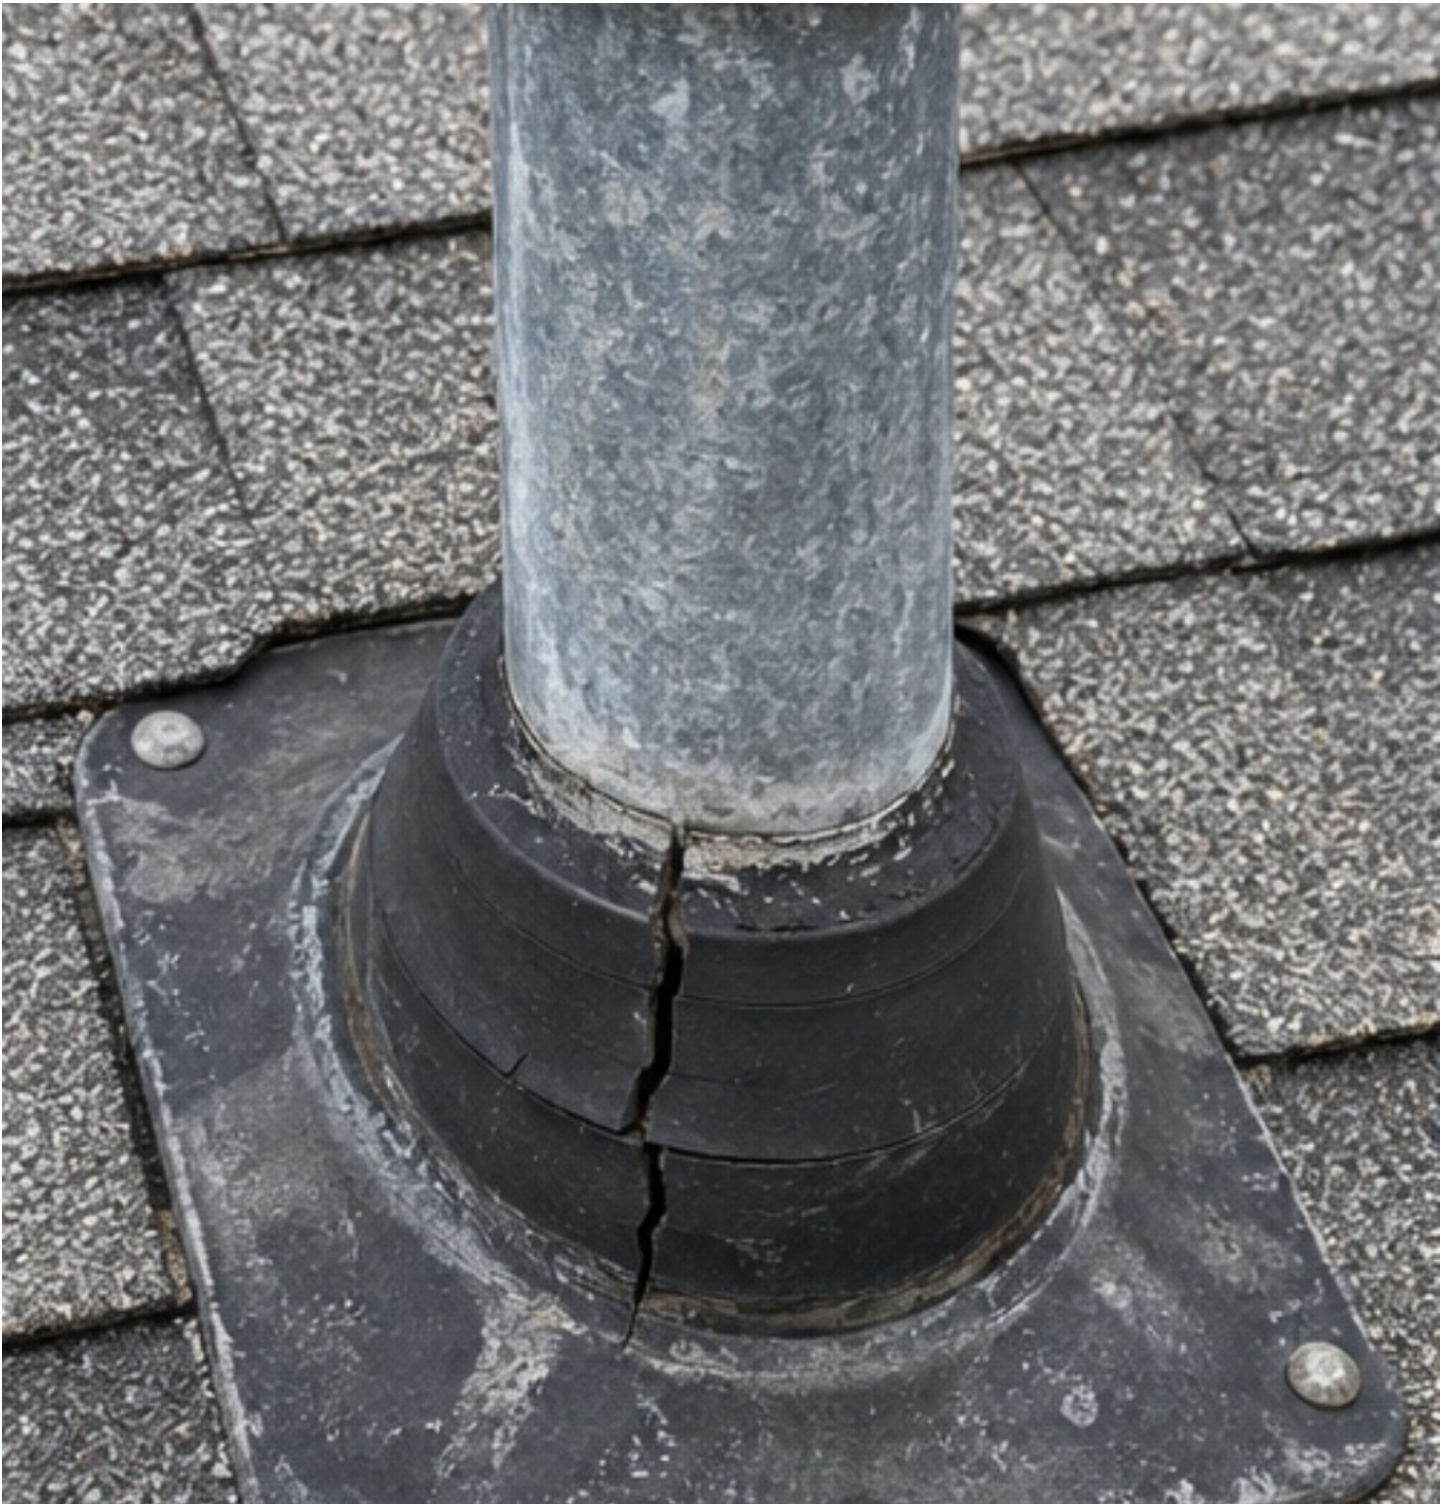
Photo 3: Weathered flashing boot at the roof vent.

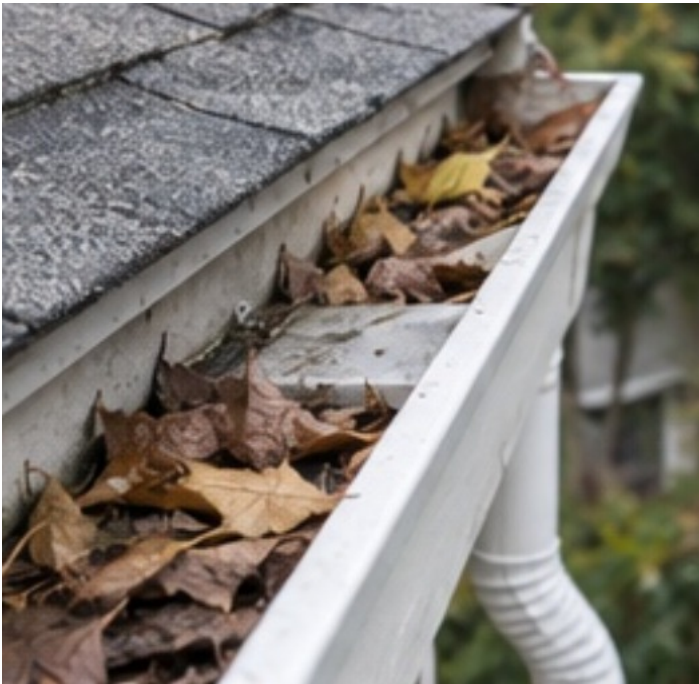
Photo 4: Debris in the gutter near the outlet.

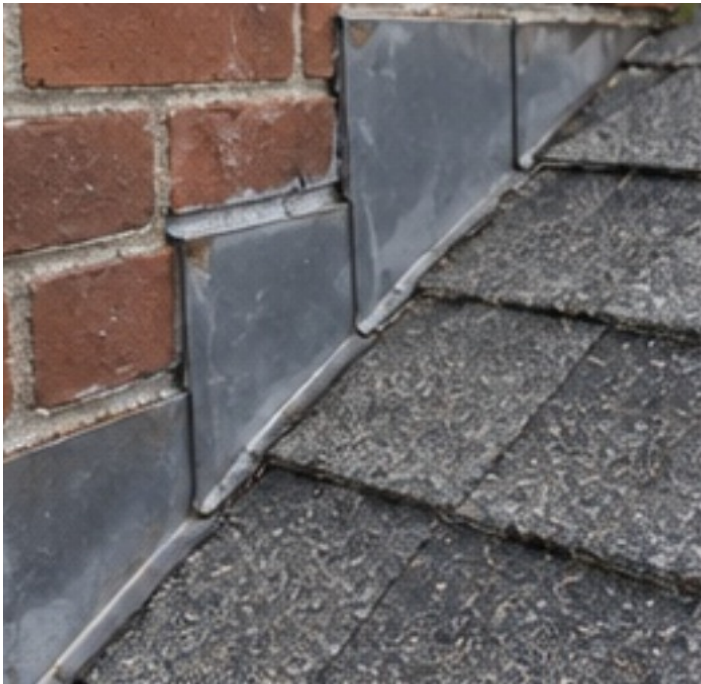
Photo 5: Step flashing at the chimney.

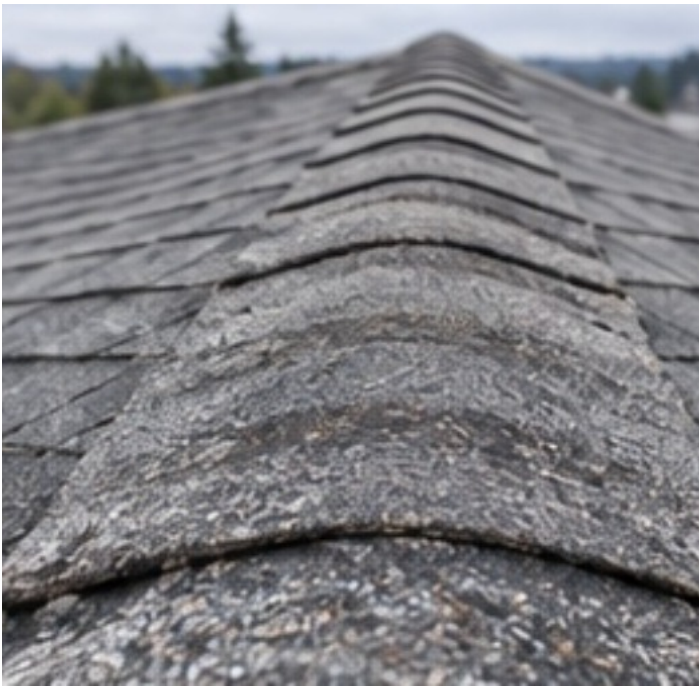
Photo 6: Condition of the ridge shingles.

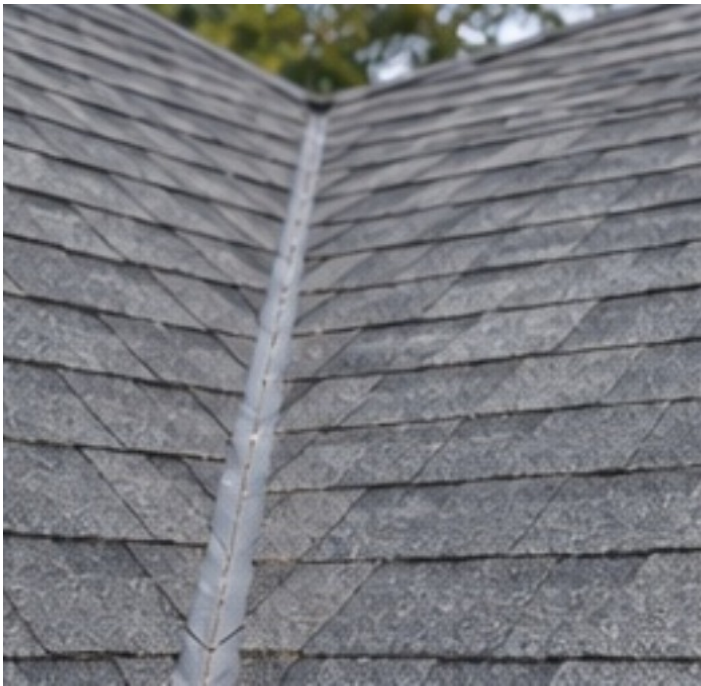
Photo 7: Roof valley and intersecting slopes.

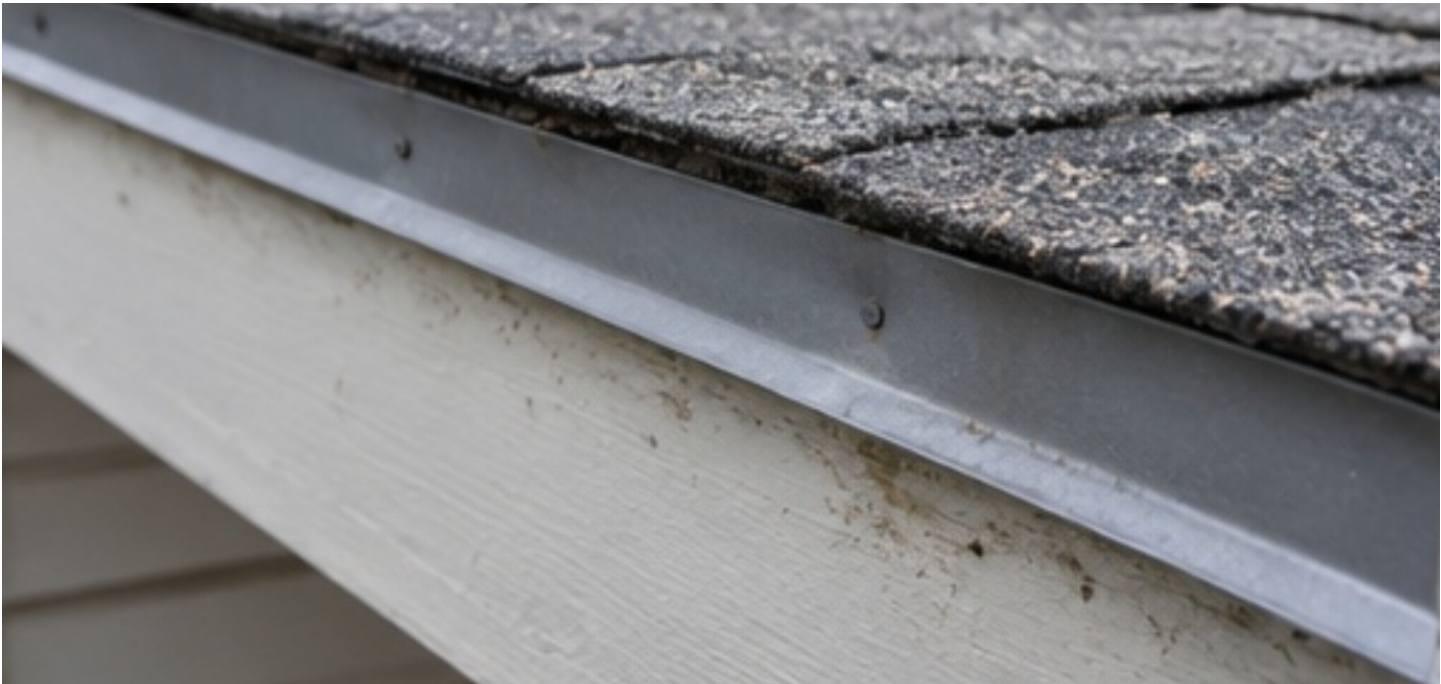
Photo 8: Drip edge and fascia detail.

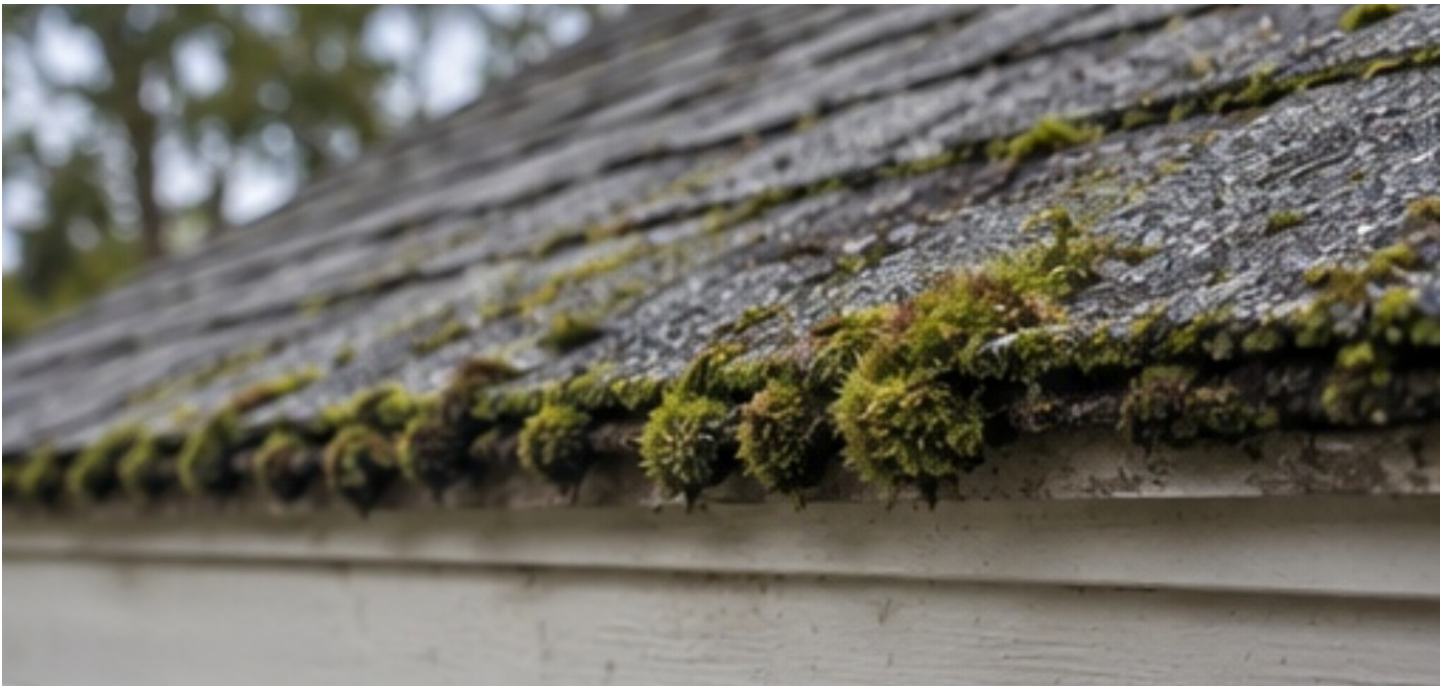
Photo 9: Moss along the shaded roof edge.
