| <b>REPORT TITLE</b><br><b>Groundwater &amp; Soil Monitoring</b><br><br><b>PROJECT DESCRIPTION</b><br>Field observations - Illustrative sample | <b>PROJECT NO.</b><br>ENV-26058 | <b>CLIENT</b><br>Example Properties | <b>SITE</b><br>Meadowbrook Monitoring Site |

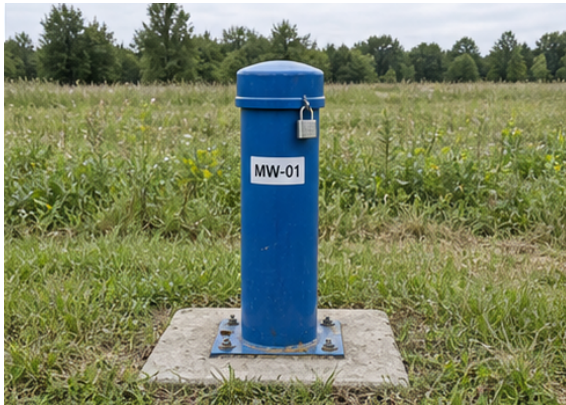
Photo 1: Monitoring well MW-01 and protective casing.

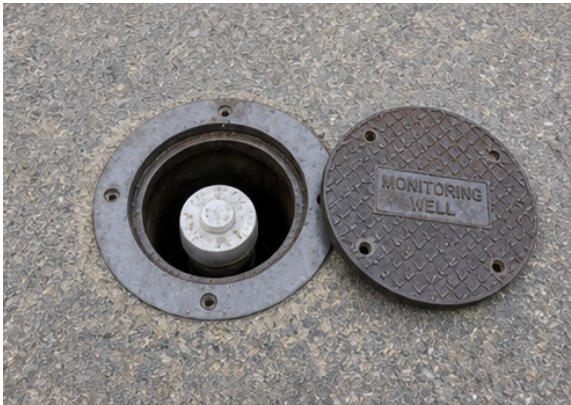
Photo 2: Flush-mount well MW-02 in the service yard.

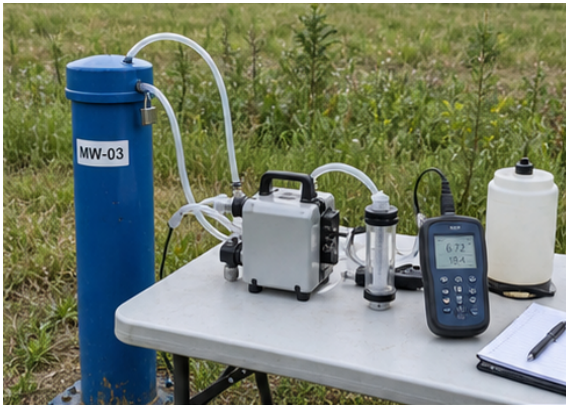
Photo 3: Groundwater sampling setup at MW-03.

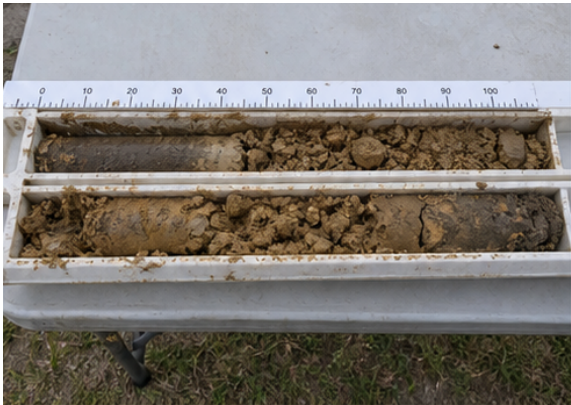
Photo 4: Recovered soil core from borehole BH-04.

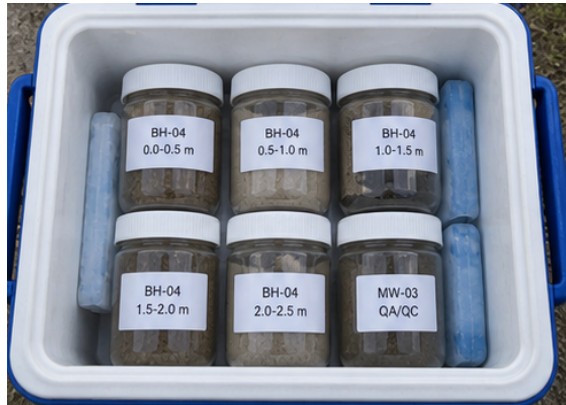
Photo 5: Soil sample containers prepared for transport.

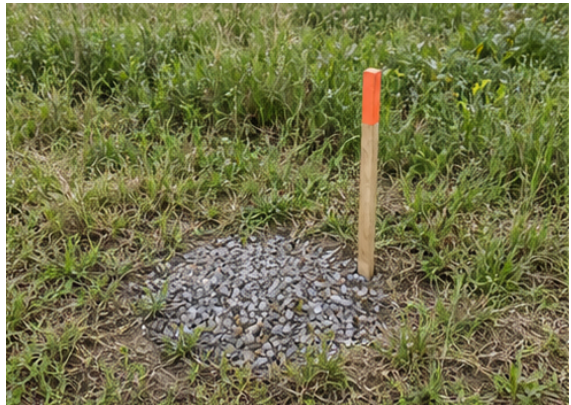
Photo 6: Completed borehole location following reinstatement.
